# Investigation of the UH-60 Main Rotor Spindle Assembly Retaining Rods P/N 70102-08102/-103

ARL-TR-1585

January 1998

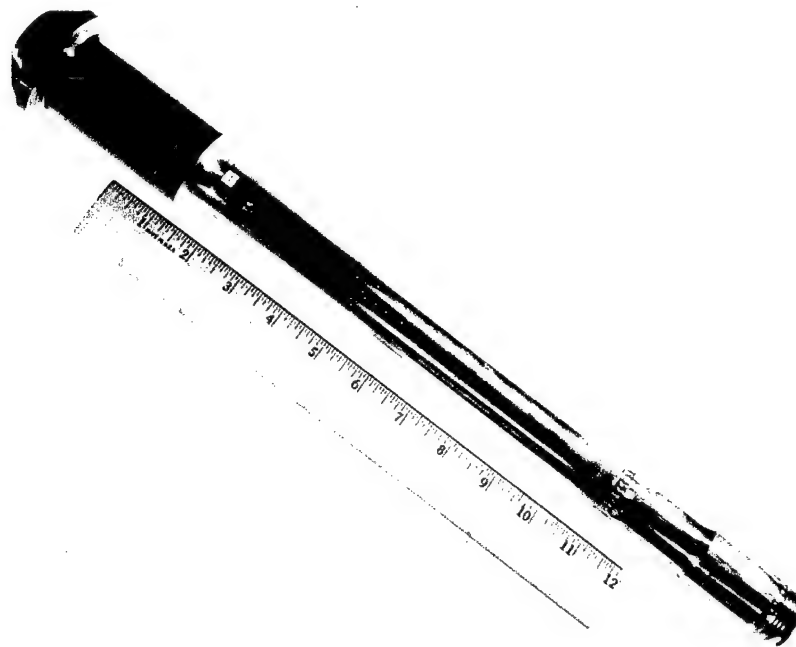
The as-received condition of the two halves of the failed retaining rods manufactured by SIK -00938 and -00973 are depicted in Figures 1–4, respectively. The as-received condition of the two halves of the failed retaining rods manufactured by PUR -174 and -177 are shown in Figures 5–8, respectively. Figures 9 and 10 depict the as-received failed retaining rods (opposite fracture halves were not received) manufactured by S&S -2 and -3, respectively. Each of the six failed spindle retaining rods was visually examined utilizing light optical microscopy. All six failures originated within the threaded section of the respective rods.

**Figure 1. Failed SIK Rod -00938 in the As-Received Condition (Reduced 75%).**

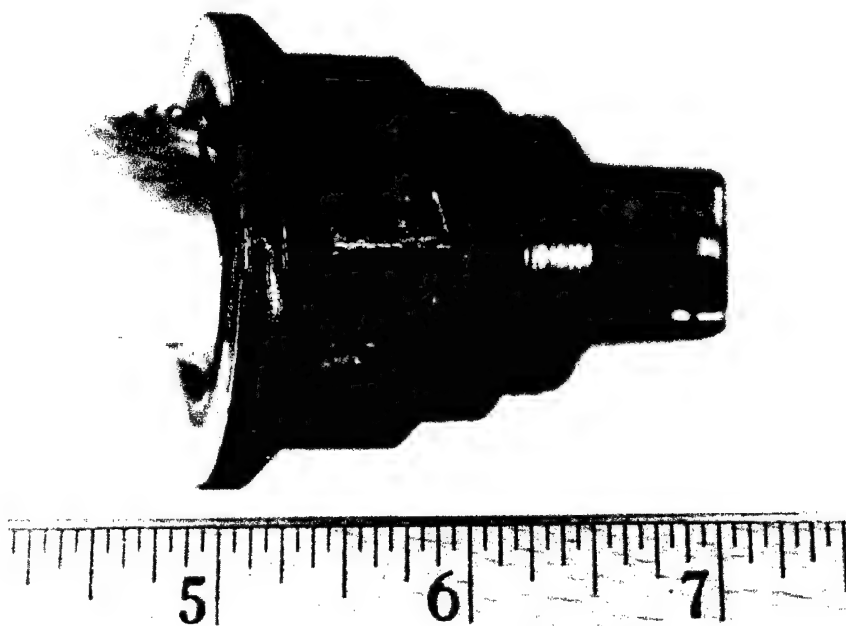
**Figure 2. Failed Threaded End of SIK Rod -00938 in the As-Received Condition (Mag. 1.25x).**

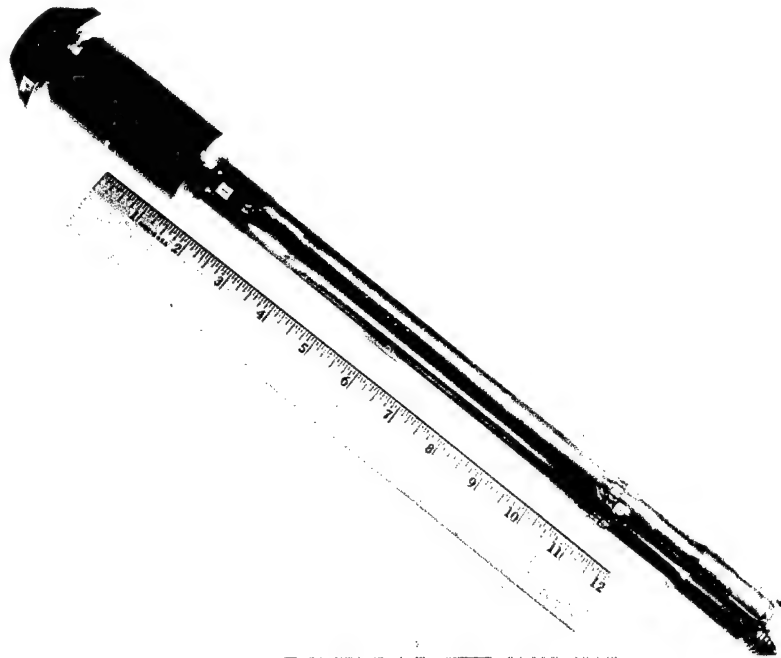
**Figure 3. Failed SIK Rod -00973 in the As-Received Condition (Reduced 75%).**

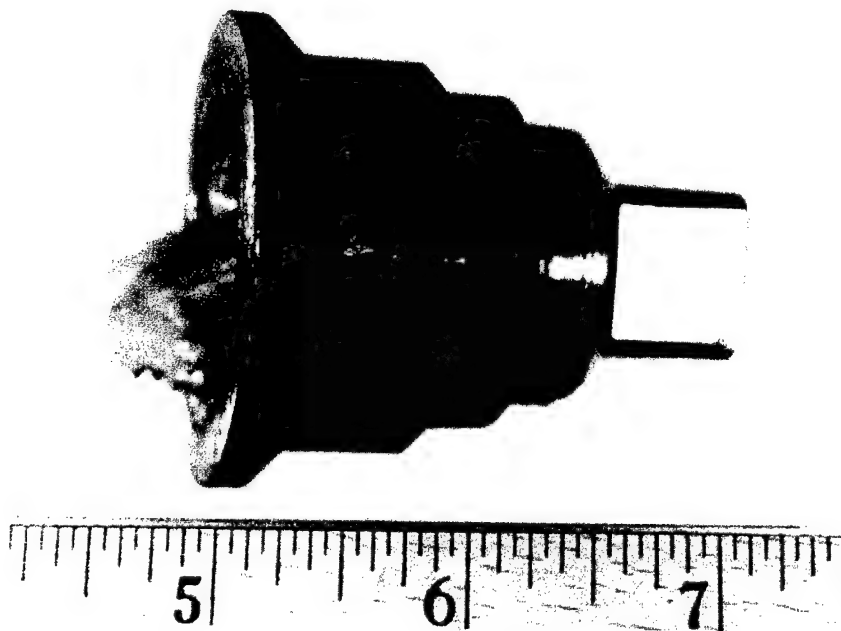
**Figure 4. Failed Threaded End of SIK Rod -00973 in the As-Received Condition (Mag. 1.25x).**

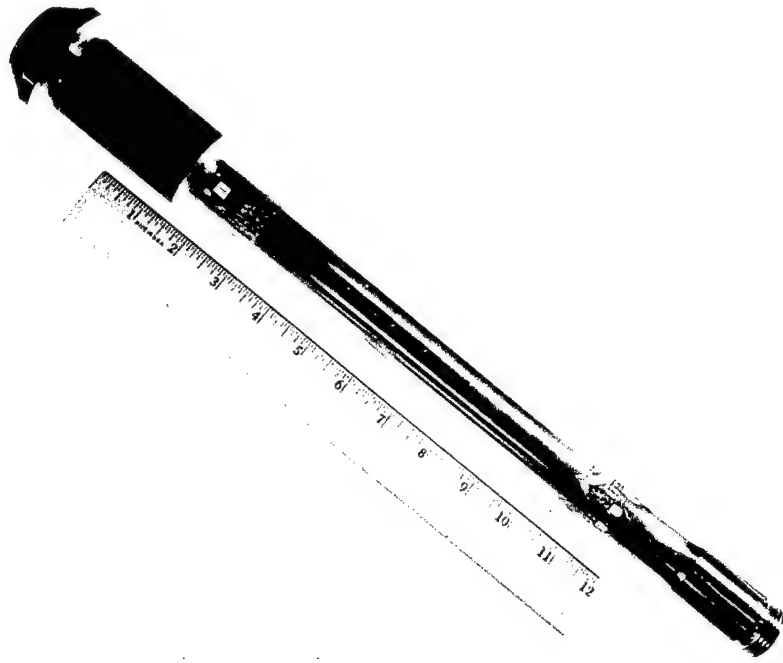
**Figure 5. Failed PUR Rod -174 in the As-Received Condition (Reduced 75%).**

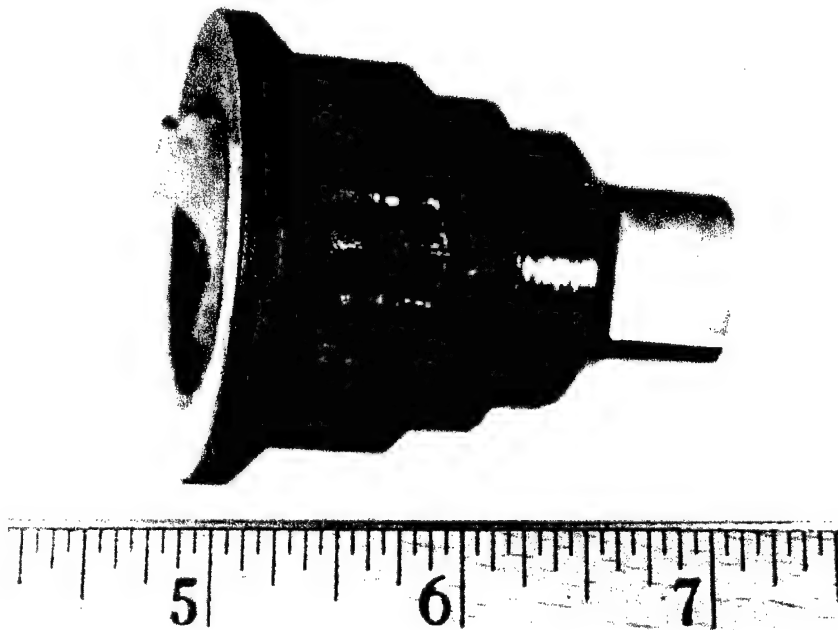
**Figure 6. Failed Threaded End of PUR Rod -174 in the As-Received Condition (Mag. 1.25x).**

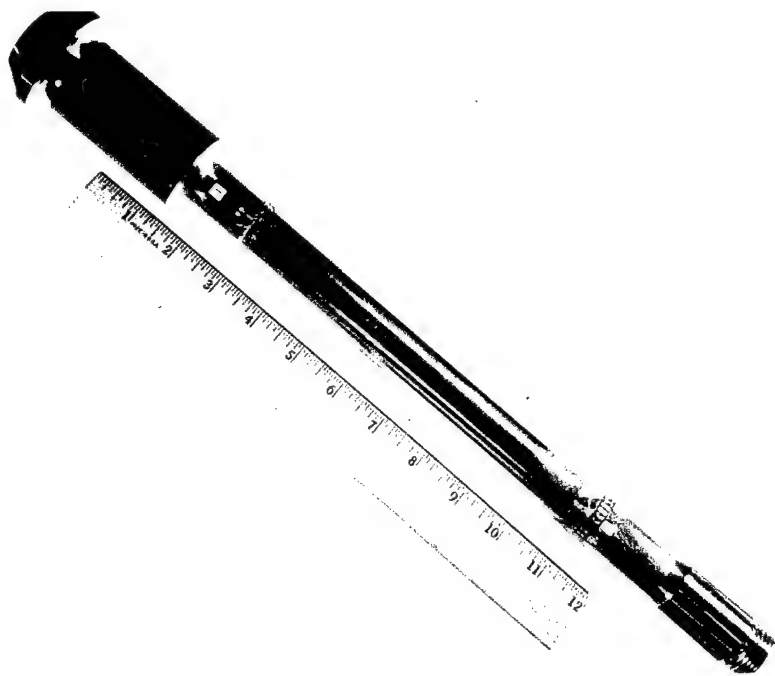
**Figure 7. Failed PUR Rod -177 in the As-Received Condition (Reduced 75%).**

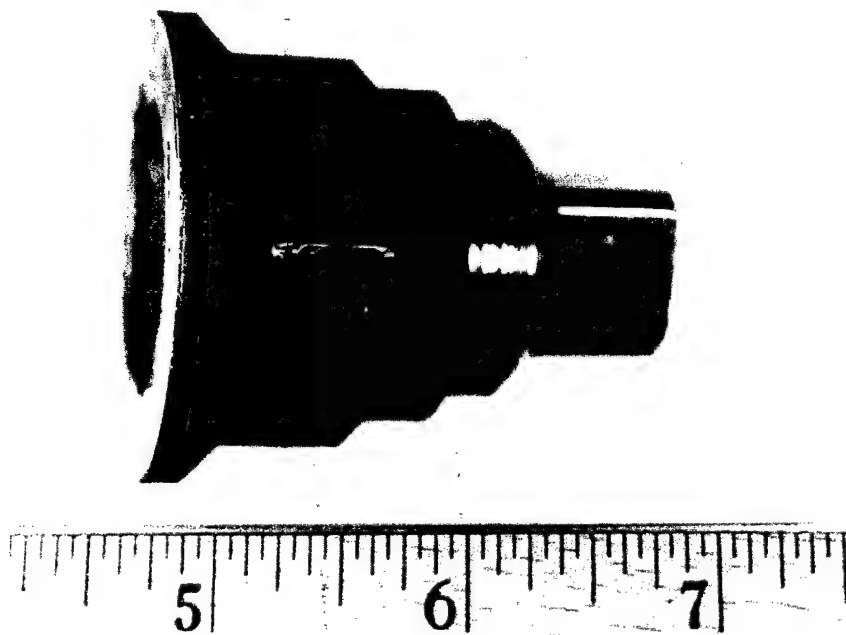
**Figure 8. Failed Threaded End of PUR Rod -177 in the As-Received Condition (Mag. 1.25x).**

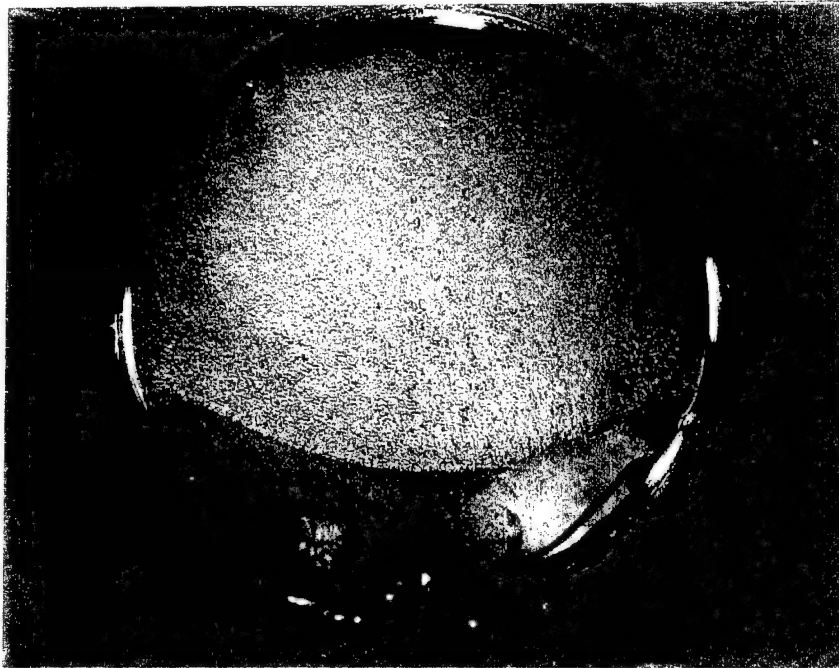
It was observed that the two failed specimens fabricated by PUR had relatively flat uniform fracture surfaces indicative of most fatigue failures. The two failed specimens had fracture surfaces that were remarkably similar. Multiple origin sites (greater than 20) were observed on both surfaces, all initiating along the root radius of the same thread. The surface profiles of the threads were examined and compared to those of SIK rods. The roots of the PUR threads were slightly rougher, containing more pronounced tool marks. No other abnormalities were observed along the threads. The fatigue zones covered approximately 80% of the fracture surface of the PUR rods, while the overload regions accounted for only 20% of the fracture surface. The fracture surfaces of the PUR failed specimens -174 and -177 are presented in Figures 14 and 15, respectively. The fatigue cracks propagated on a single plane, and no evidence of competing or secondary cracks was noted.

**Figure 14. Fracture Surface of PUR Rod -174 in the As-Received Condition. Note the Increased Fatigue Zone as Opposed to the Fracture Surfaces of the SIK Rods (Mag. 2x).**

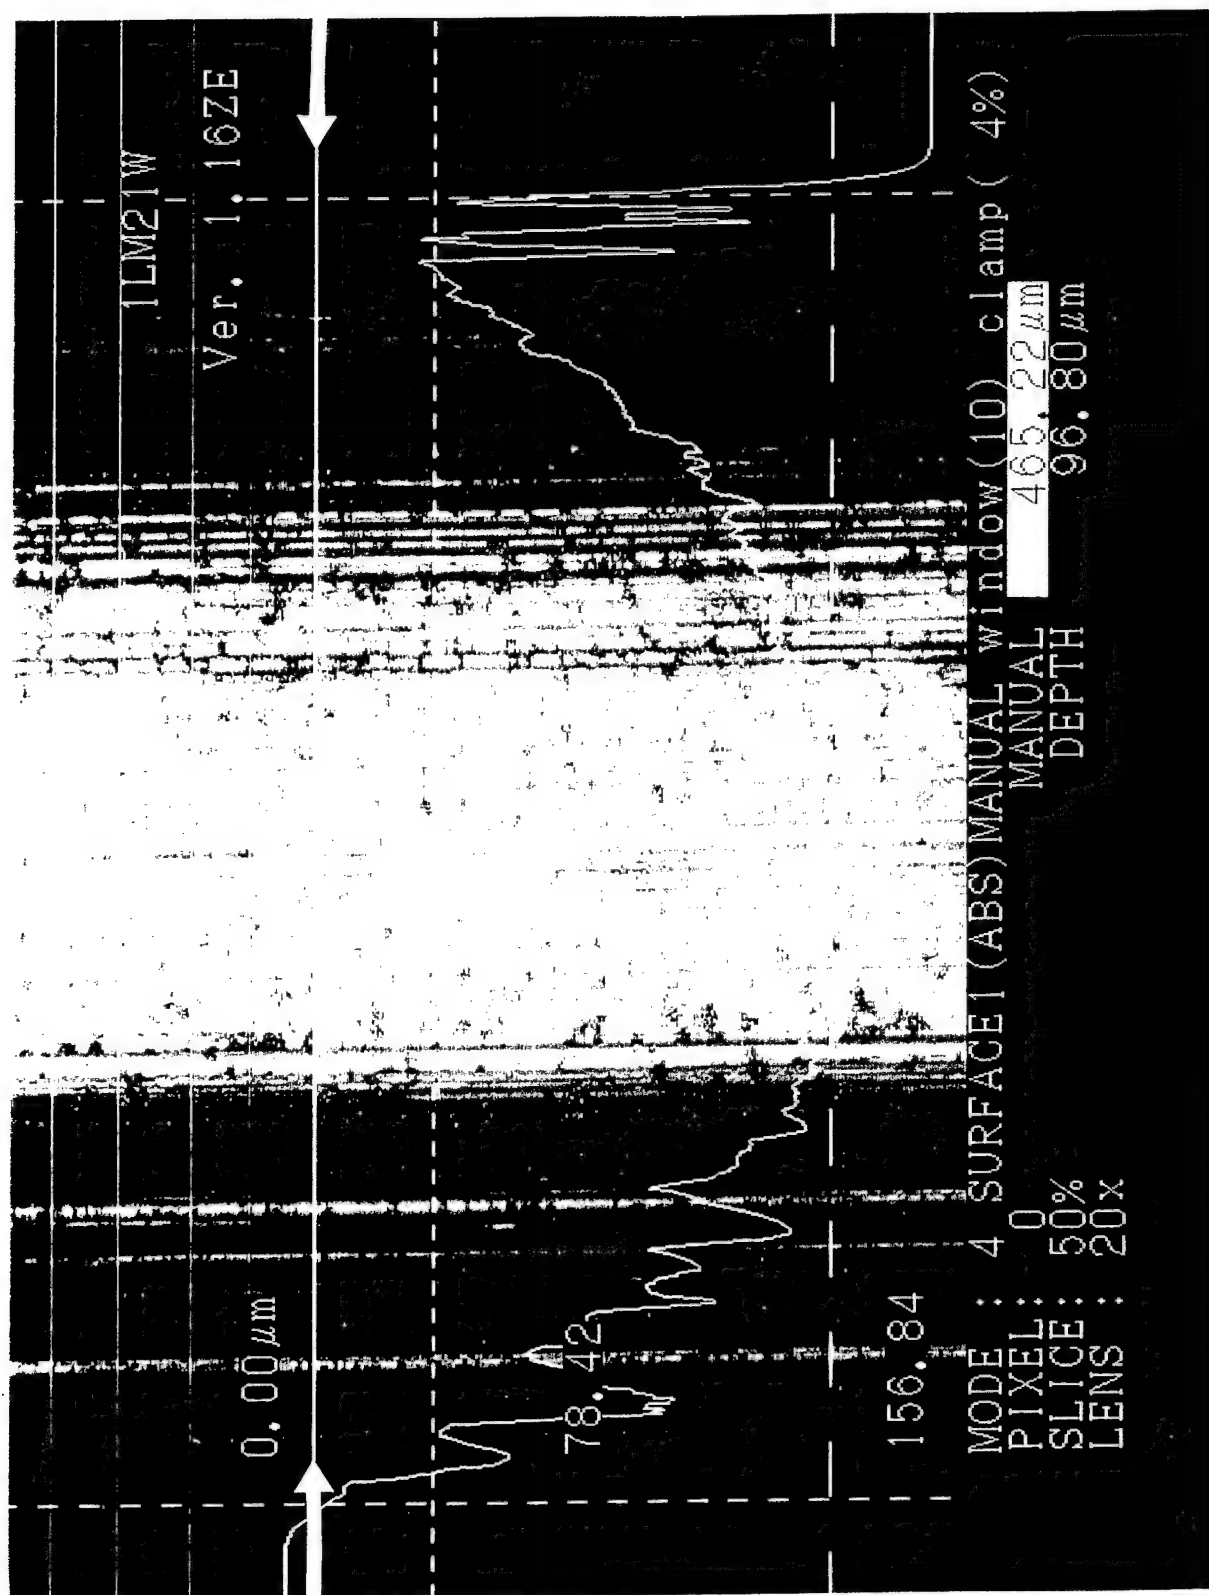
Figure 19. Lasertec Linear Scan Profile of SIK -00938 Rod Typical Thread Root (Mag. 500x).

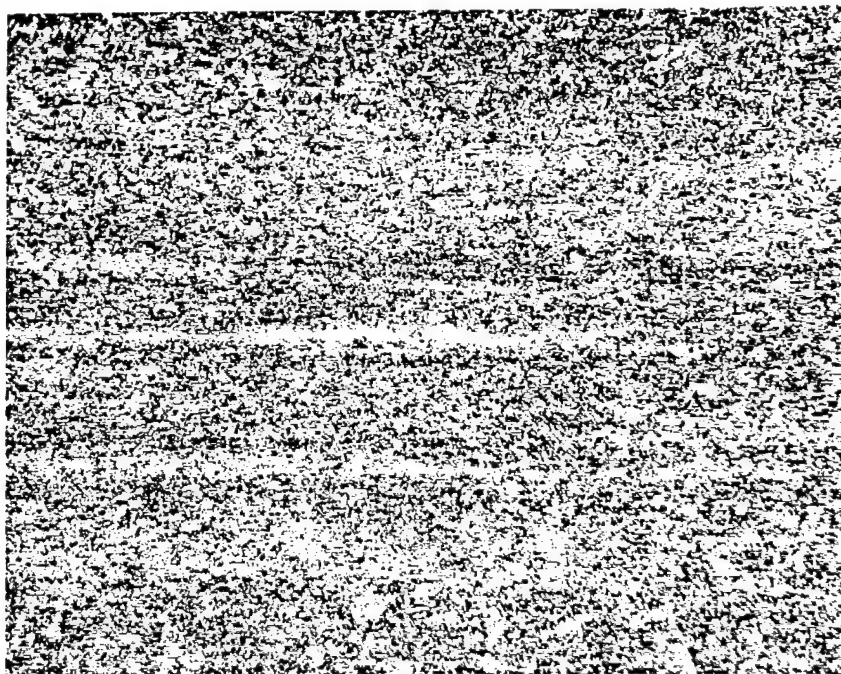
**Figure 37. Structure of SIK -00973 in the Longitudinal Direction Showing Minimal Delta Ferrite Within the Banding. This Was the Only Delta Ferrite Noted Within the Structure of the SIK Samples. Vilella's Reagent (Mag. 100×).**

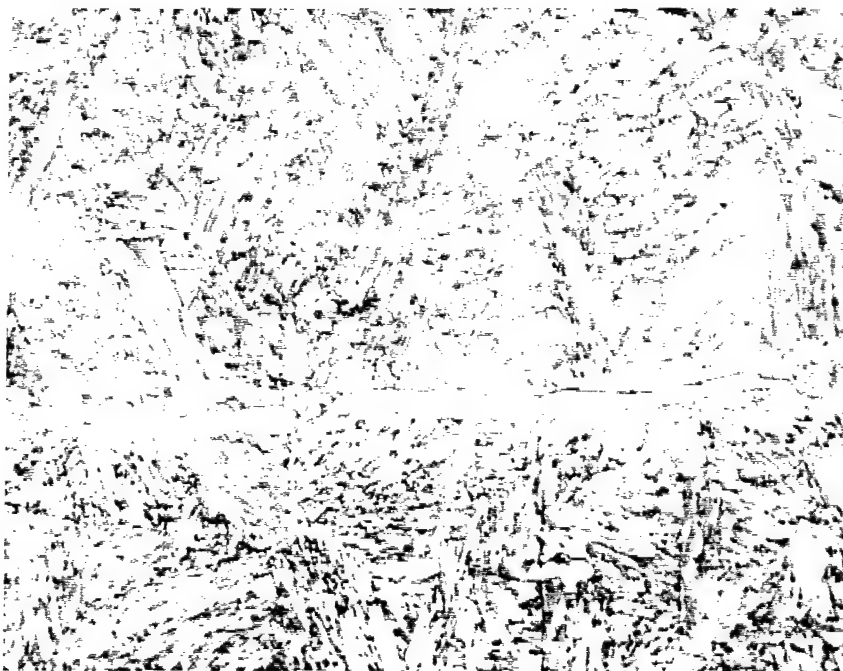
**Figure 38. Enlarged View of a Ferrite Stringer Noted Within PUR Sample -174. Vilella's Reagent (Mag. 1kx).**

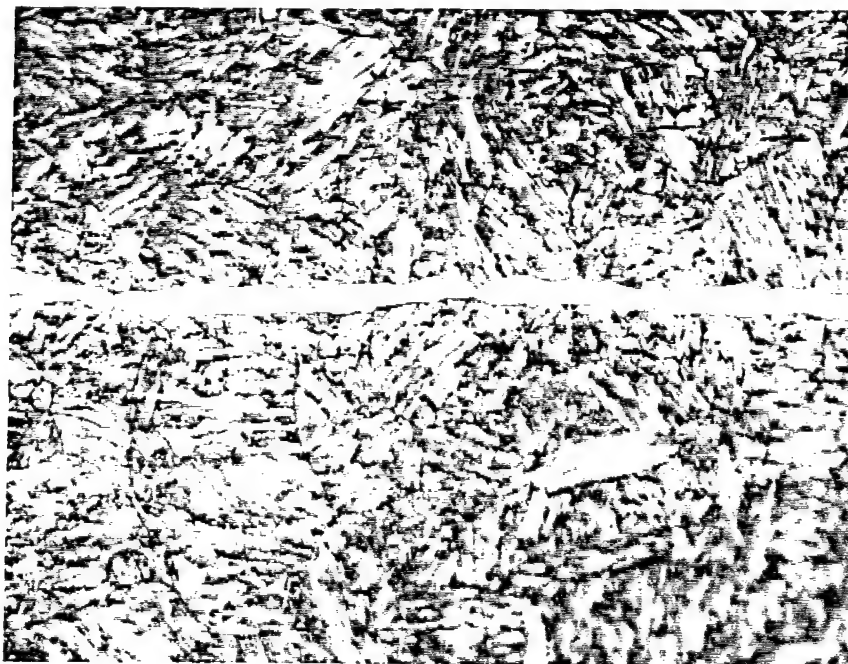
**Figure 40. Enlarged View of the Ferrite Stringer Noted Within SIK Sample -00973. Vilella's Reagent (Mag. 1kx).**

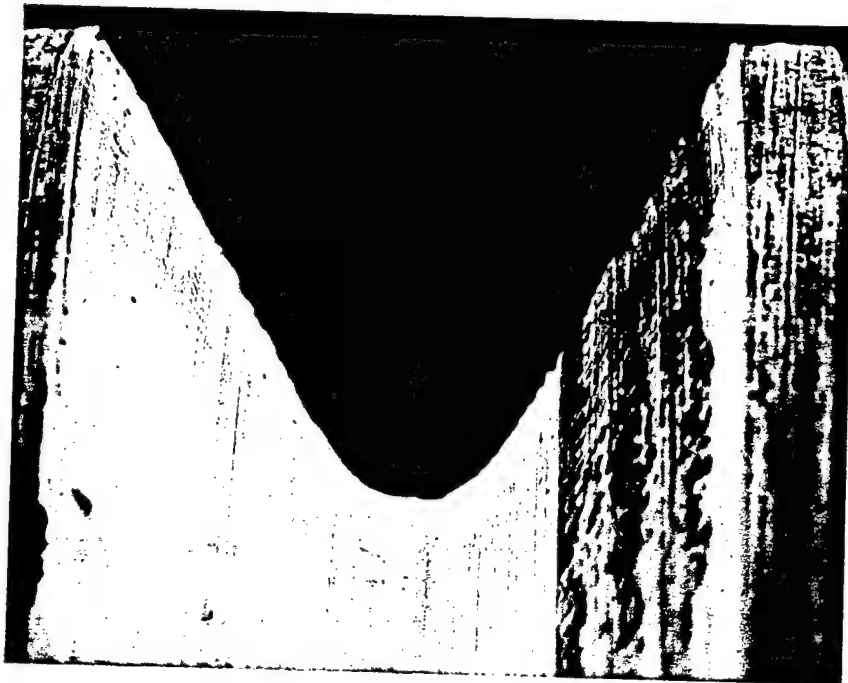
**Figure 55. SEM Micrograph Depicting the Rough PUR Thread Root (Mag. 50x).**

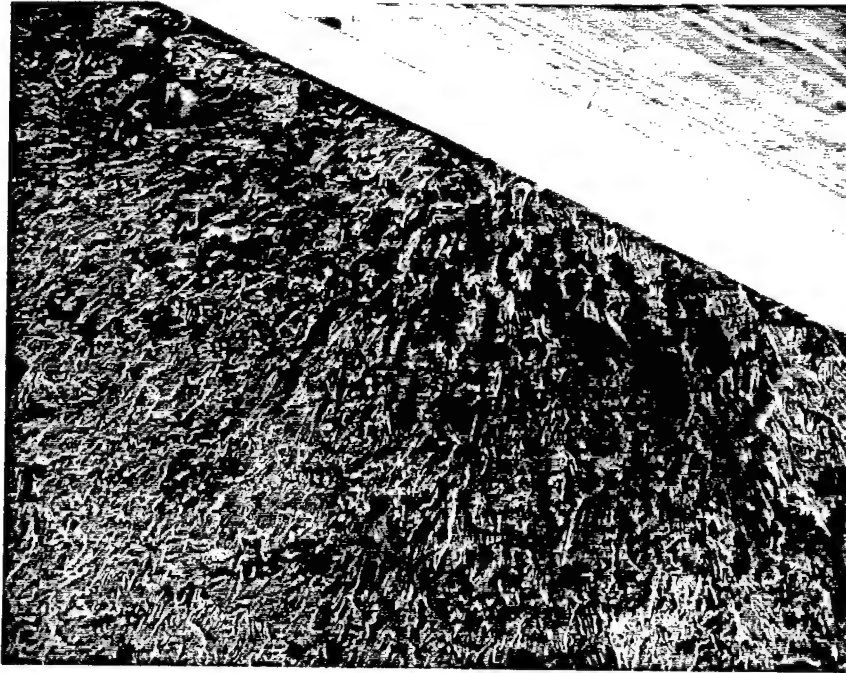
**Figure 62. A Typical Origin on the Fracture Surface of SIK Rod -00938 (Mag. 500x).**

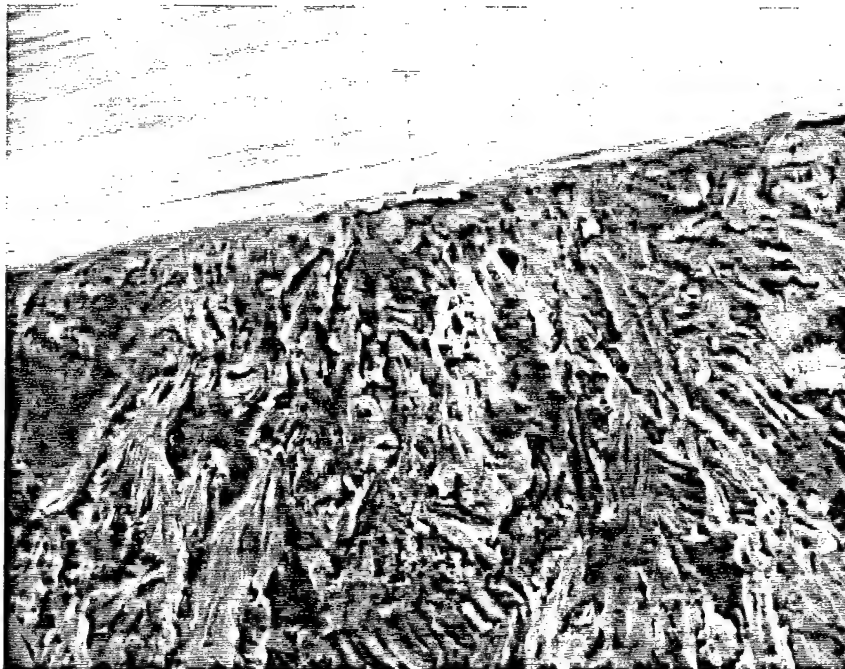
**Figure 63. Another Origin on the Fracture Surface of SIK Rod -00938 (Mag. 1kx).**

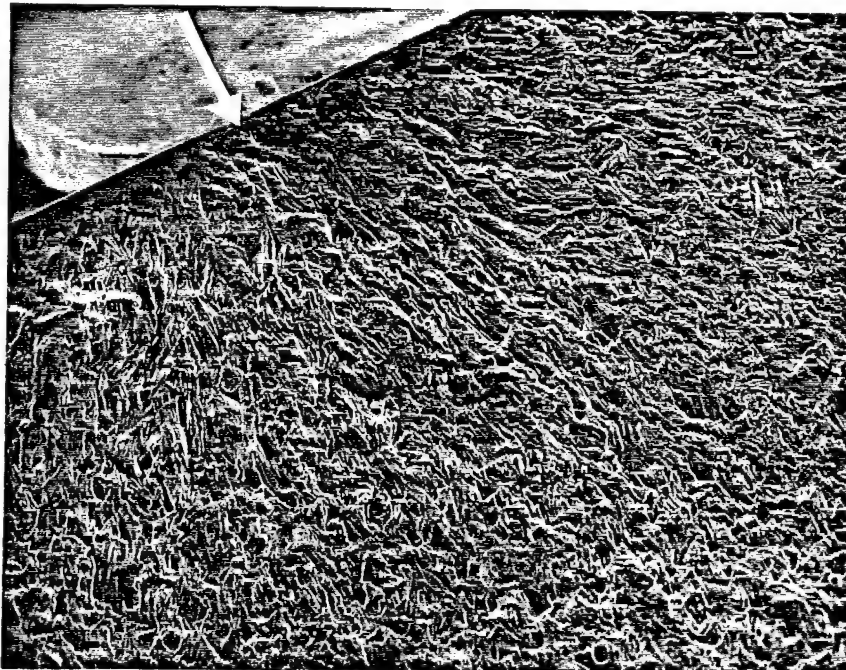
**Figure 71. Typical Origin Noted on the Fracture Surface of SIK Rod -00973 (Mag. 200x).**

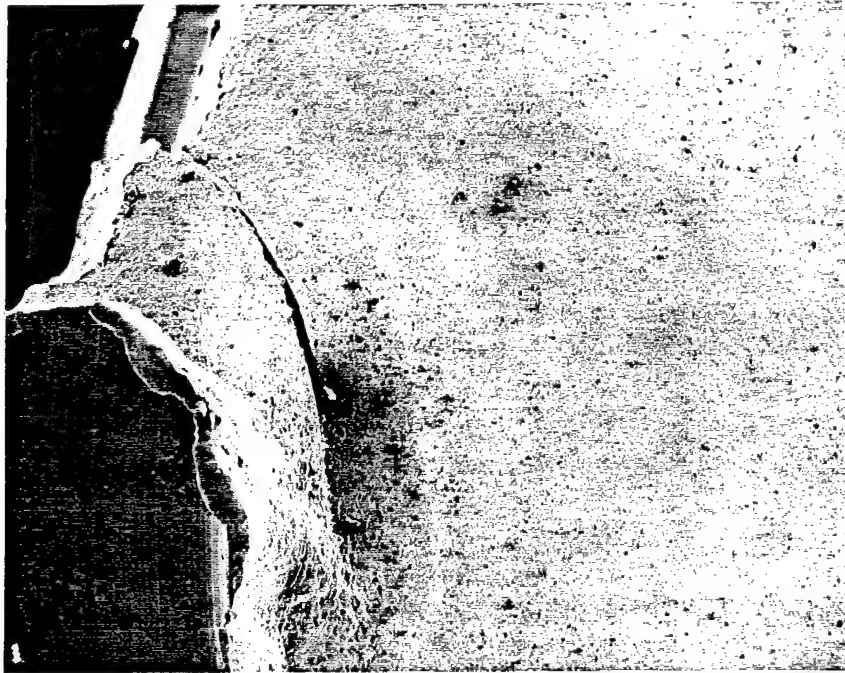
**Figure 72. Typical Origin Noted on the Fracture Surface of SIK Rod -00973 (Mag. 20x).**

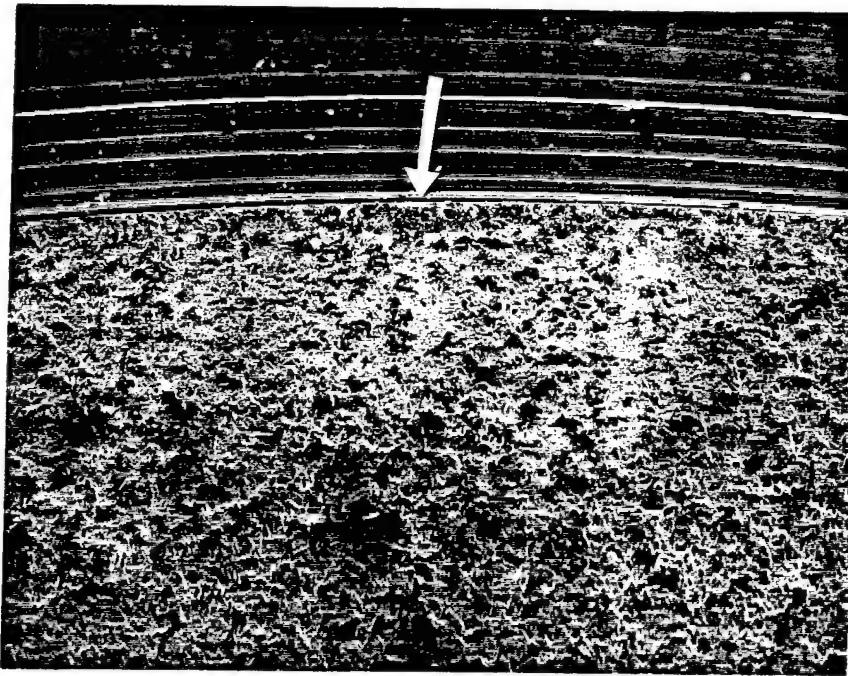
**Figure 80. Typical Origin Located on the Fracture Surface of PUR Rod -174 (Mag. 50x).**

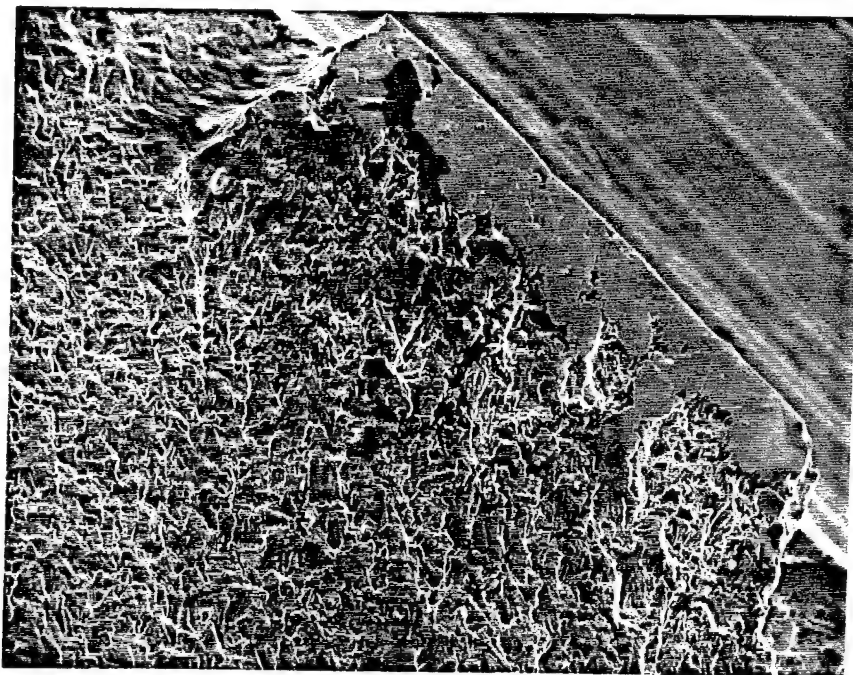
**Figure 81. Typical Origin Located on the Fracture Surface of PUR Rod -174 (Mag. 150x).**

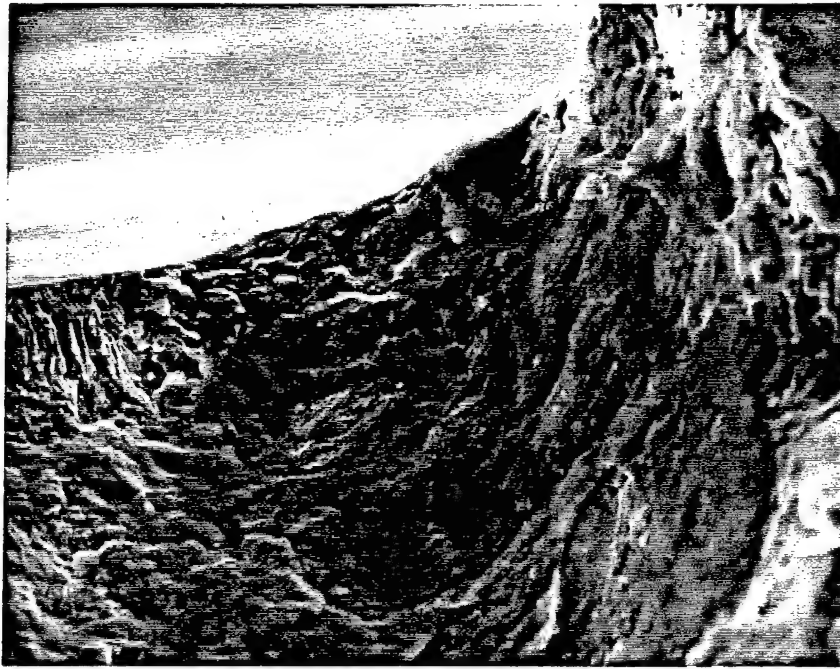
**Figure 82. Detail of Origin Located on the Fracture Surface of PUR Rod -174 (Mag. 750x).**

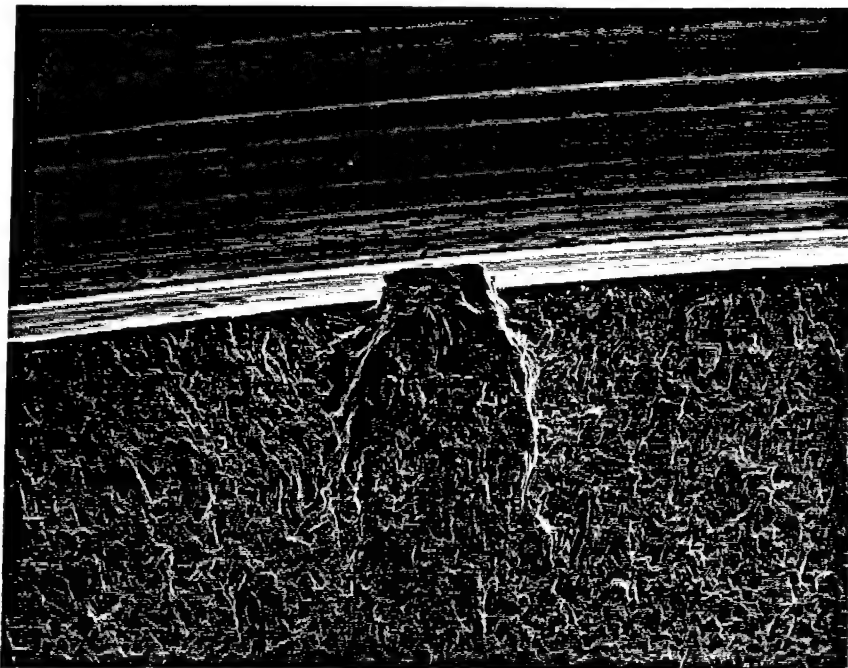
**Figure 92. A Typical Origin of PUR Rod -177 (Mag. 100×).**

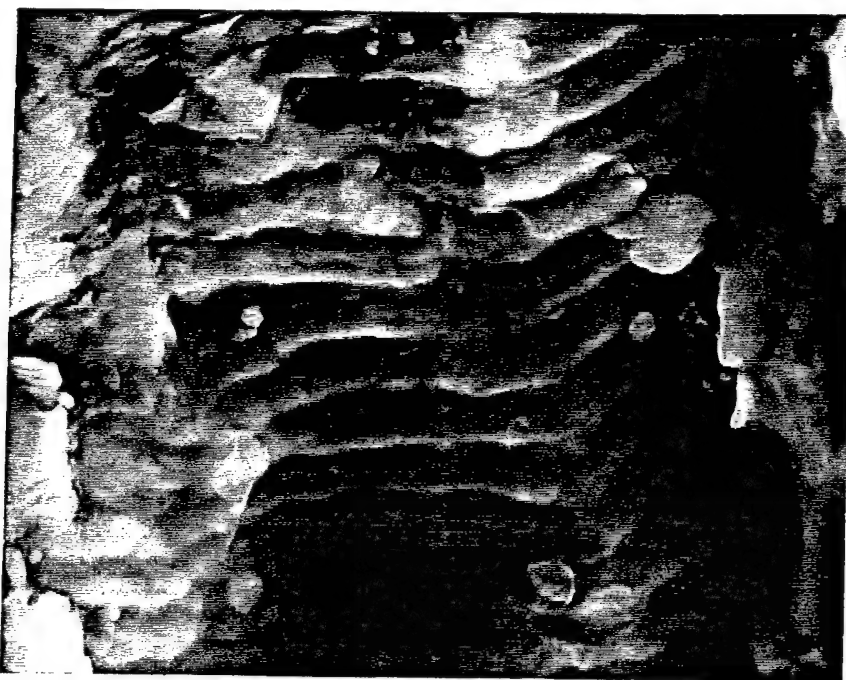
**Figure 100. Striations Noted on PUR Rod -177, Note How Spacing Is Increasing From Figure 98 and 99 (Mag. 10kx).**

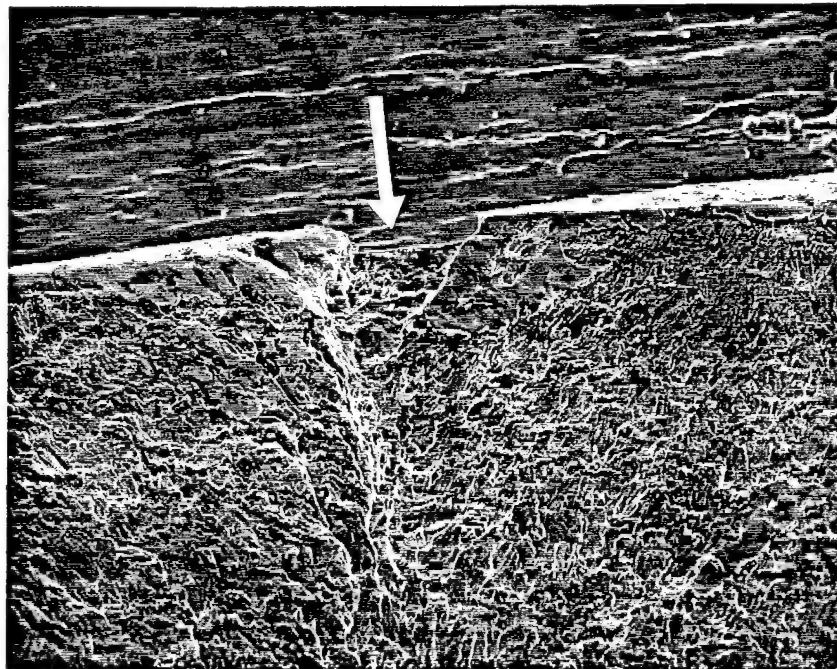
**Figure 103. A Typical Origin on the Fracture Surface of S&S Tie Rod -2 (Mag. 150x).**
